FLOOD OF APRIL-MAY 1979 IN RED RIVER OF THE NORTH BASIN, NORTH DAKOTA AND MINNESOTA

The flood of April-May 1979 on the Red River of the North has been described as the flood of the century. At most locations between Halstad, Minn., and the international boundary at Emerson, Manitoba, flood peaks were either the highest of record or the highest of this century. The destructive flood inundated over 1 million acres of valuable farm land and caused damages exceeding \$14 million dollars. In some areas downstream from Grand Forks, N. Dak., the width of the Red River exceeded 10 miles as compared to its normal width of 200 to 500 feet. Severe flooding also occurred on several tributary streams in North Dakota and Minnesota causing peak flows that exceeded previous maximums of record.

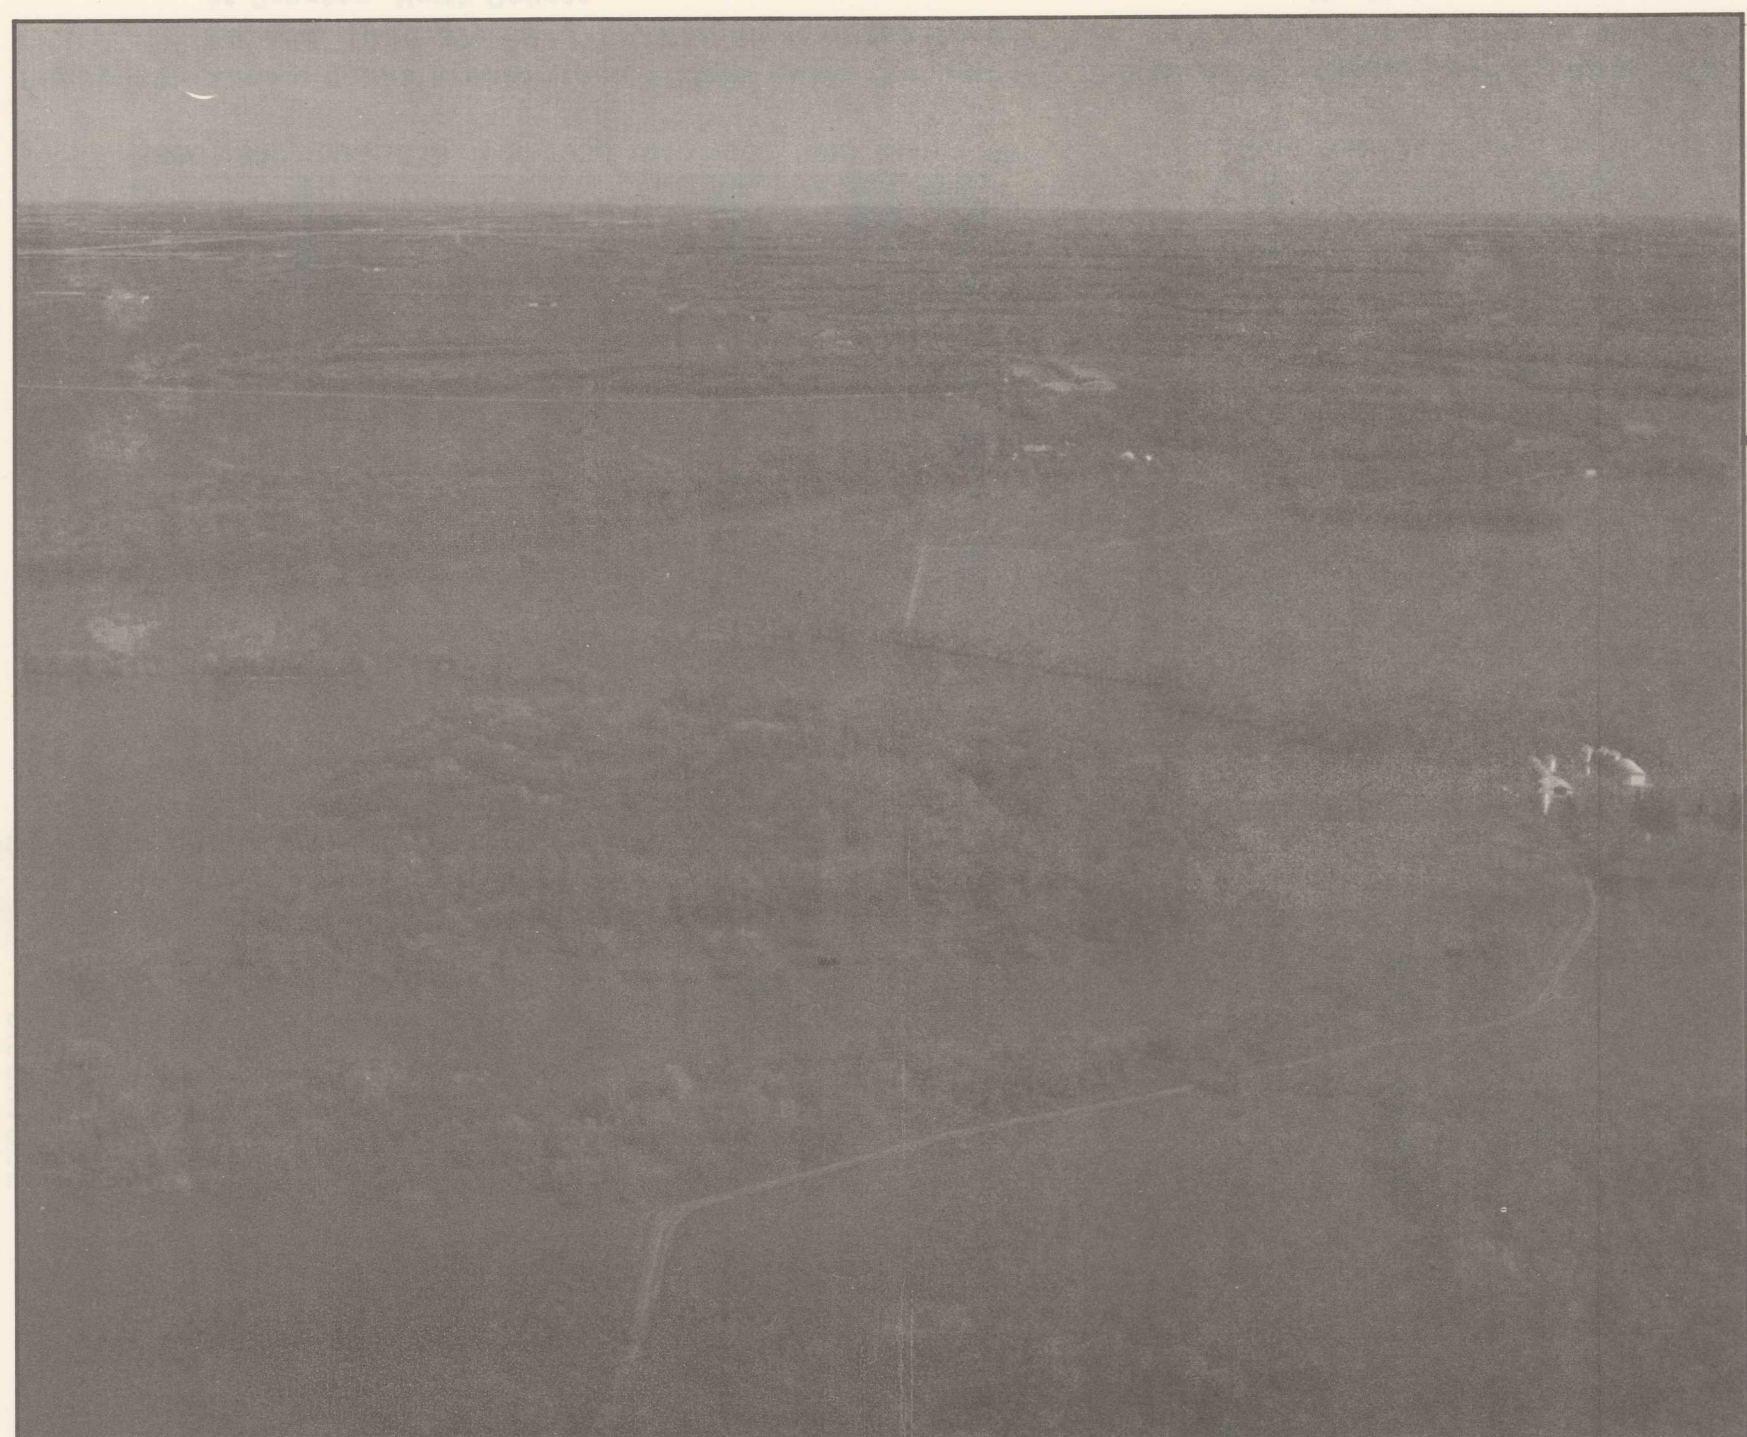
Ineffective agricultural levee south of Highway 317 on Minnesota side of the Red River. View is looking downstream (north)

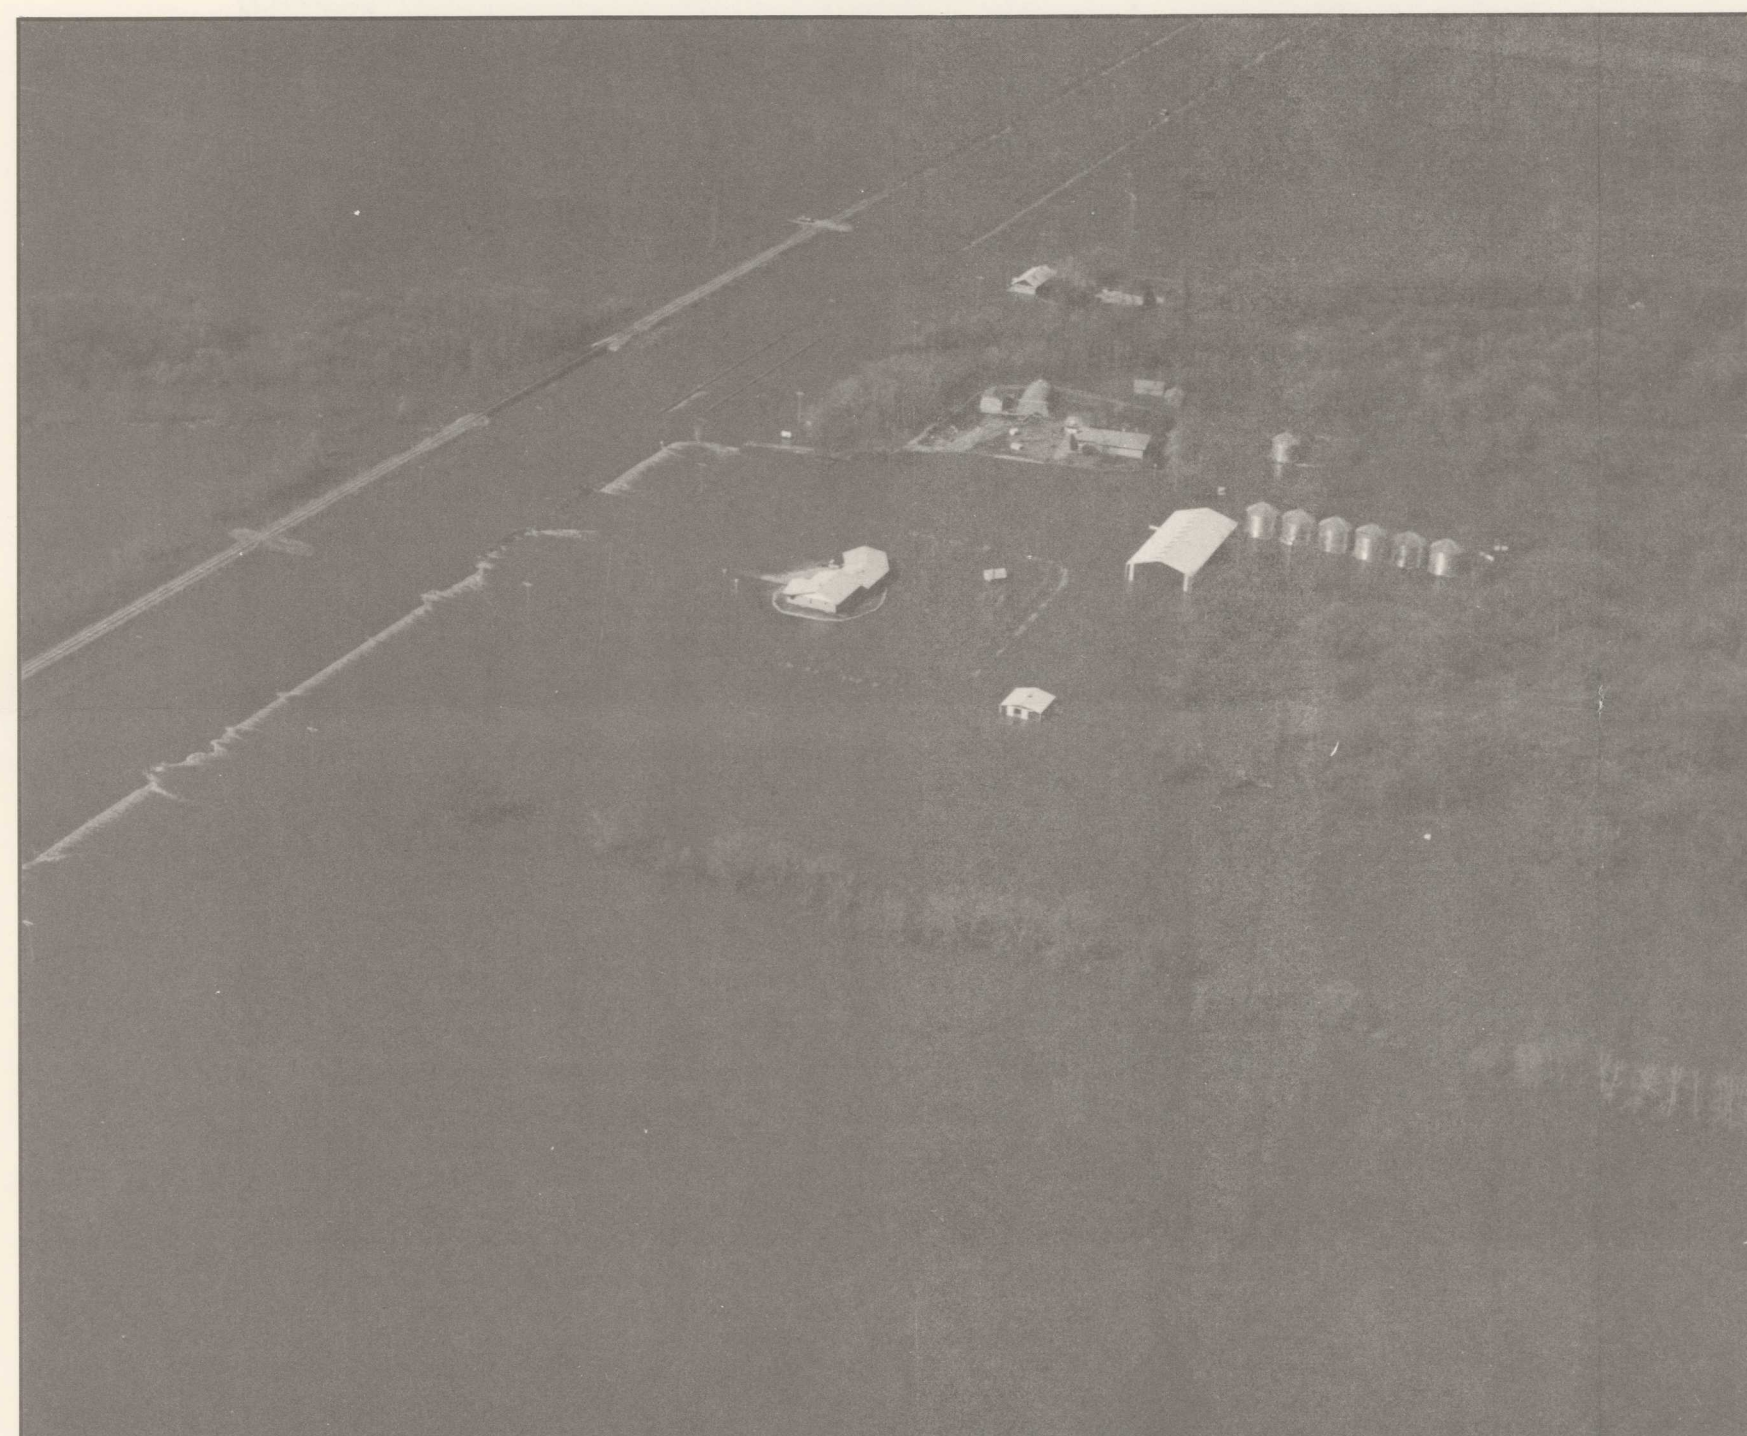
Floodwaters from the Red River engulf farms near Marais River bridge on North Dakota Highway 54. Ring dikes are effective in protecting some of the buildings. Photo date is April 27, 1979

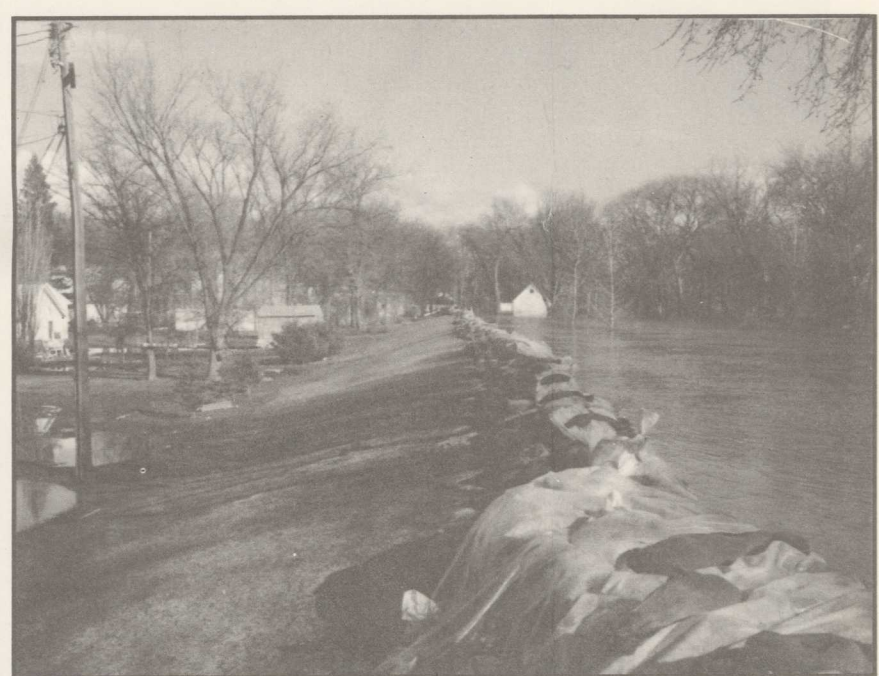
Earthen levee in Grand Forks, N. Dak. is topped with sandbags and plastic to contain the floodwaters

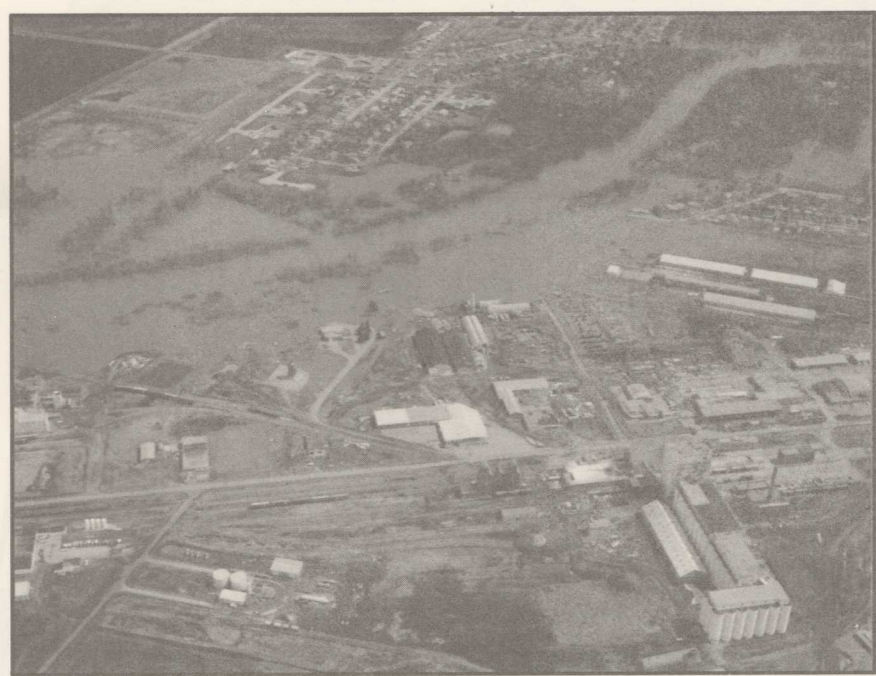
View looking east over north side of Grand Forks, N. Dak., and East Grand Forks, Minn.

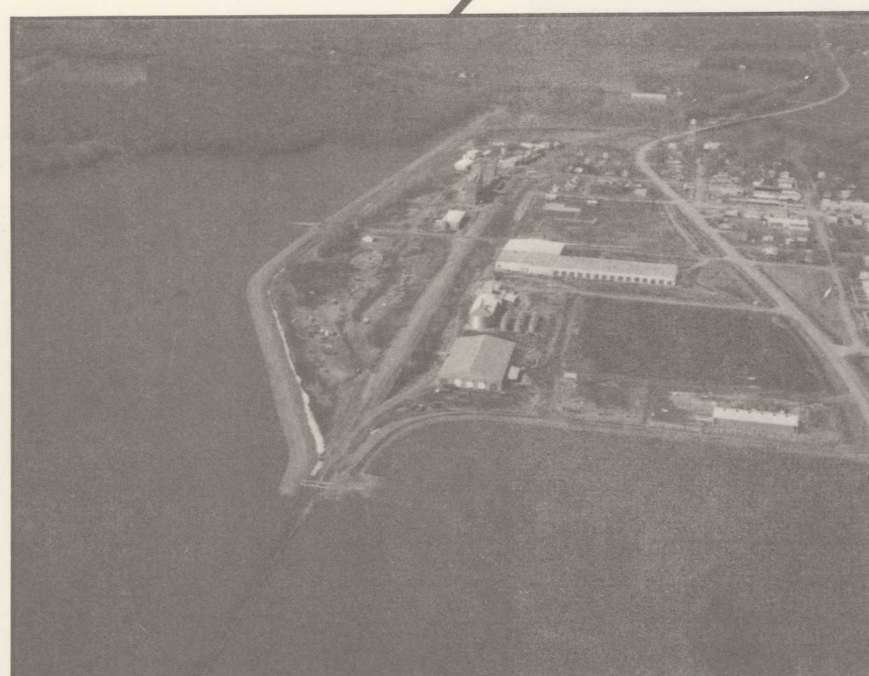
Permanent levees protect Oslo, Minn. from the flood. Main channel of the Red River is near top of the picture. Direction of flow is from left to right
